⑨ BUREAU OF SHIPS GROUP  
TECHNICAL INSPECTION REPORT

⑥ OPERATION CROSSROADS  
U.S.S. LCI's 327, 329, 332, 549.

TEST BAKER U ⑧

USS LCI's 327, 329, 332, 549

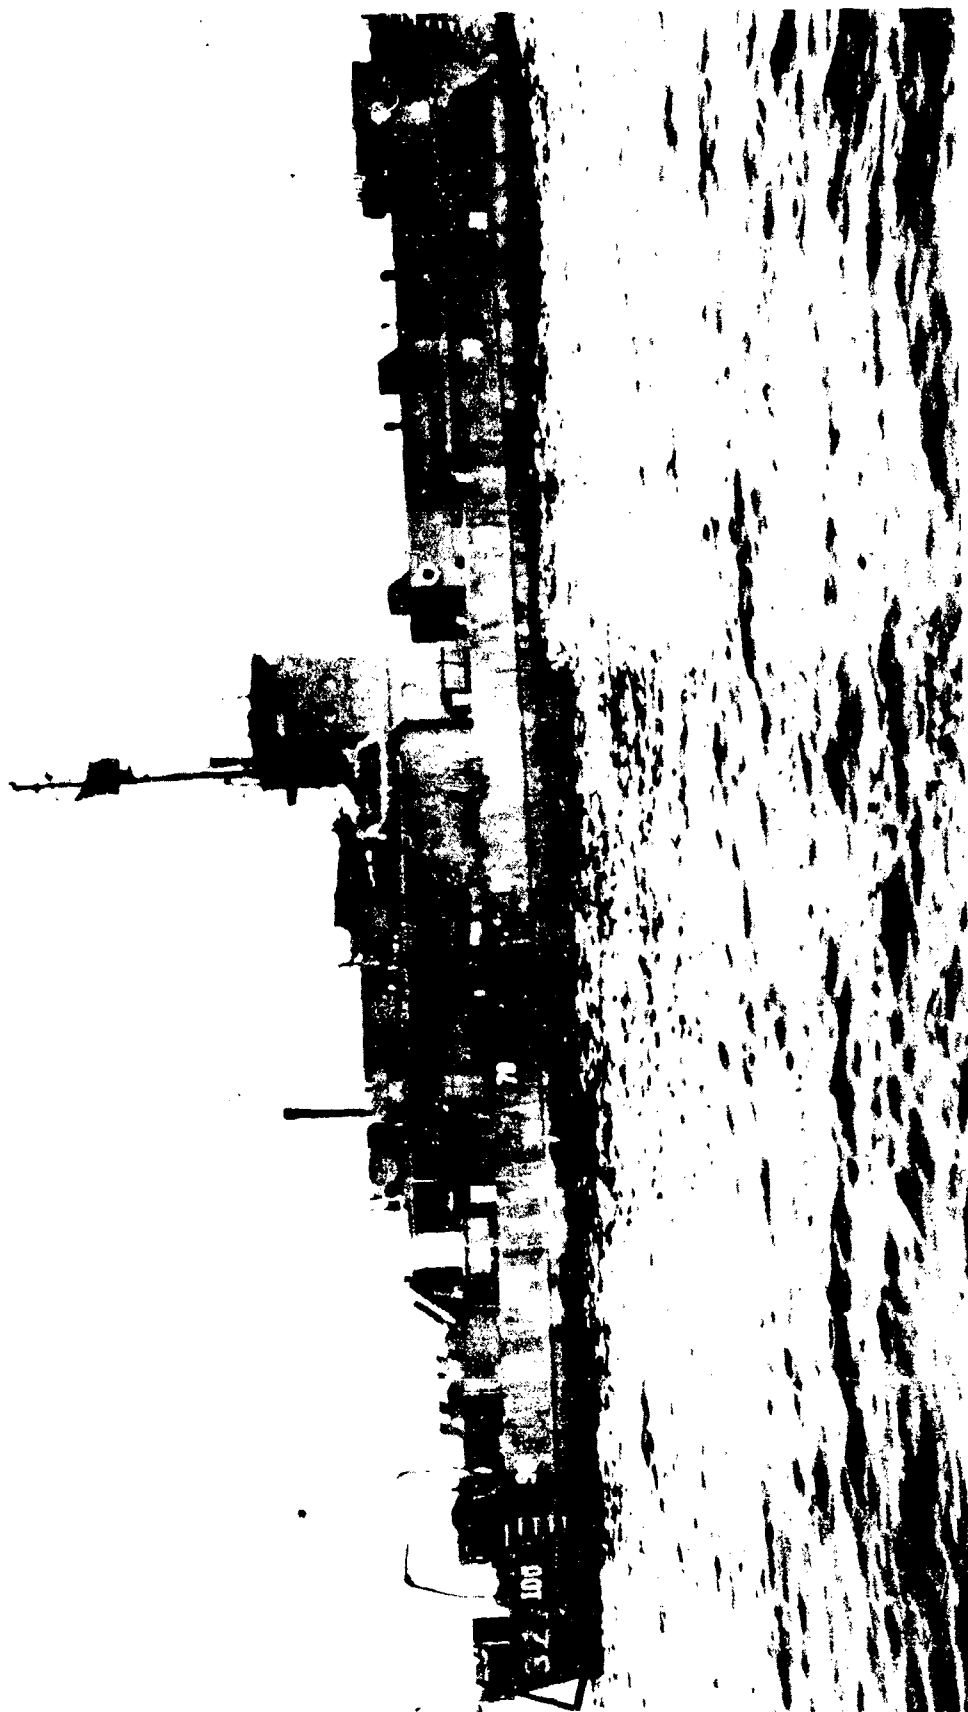
AB-CR-227-290-74. View from starboard beam after Test B.

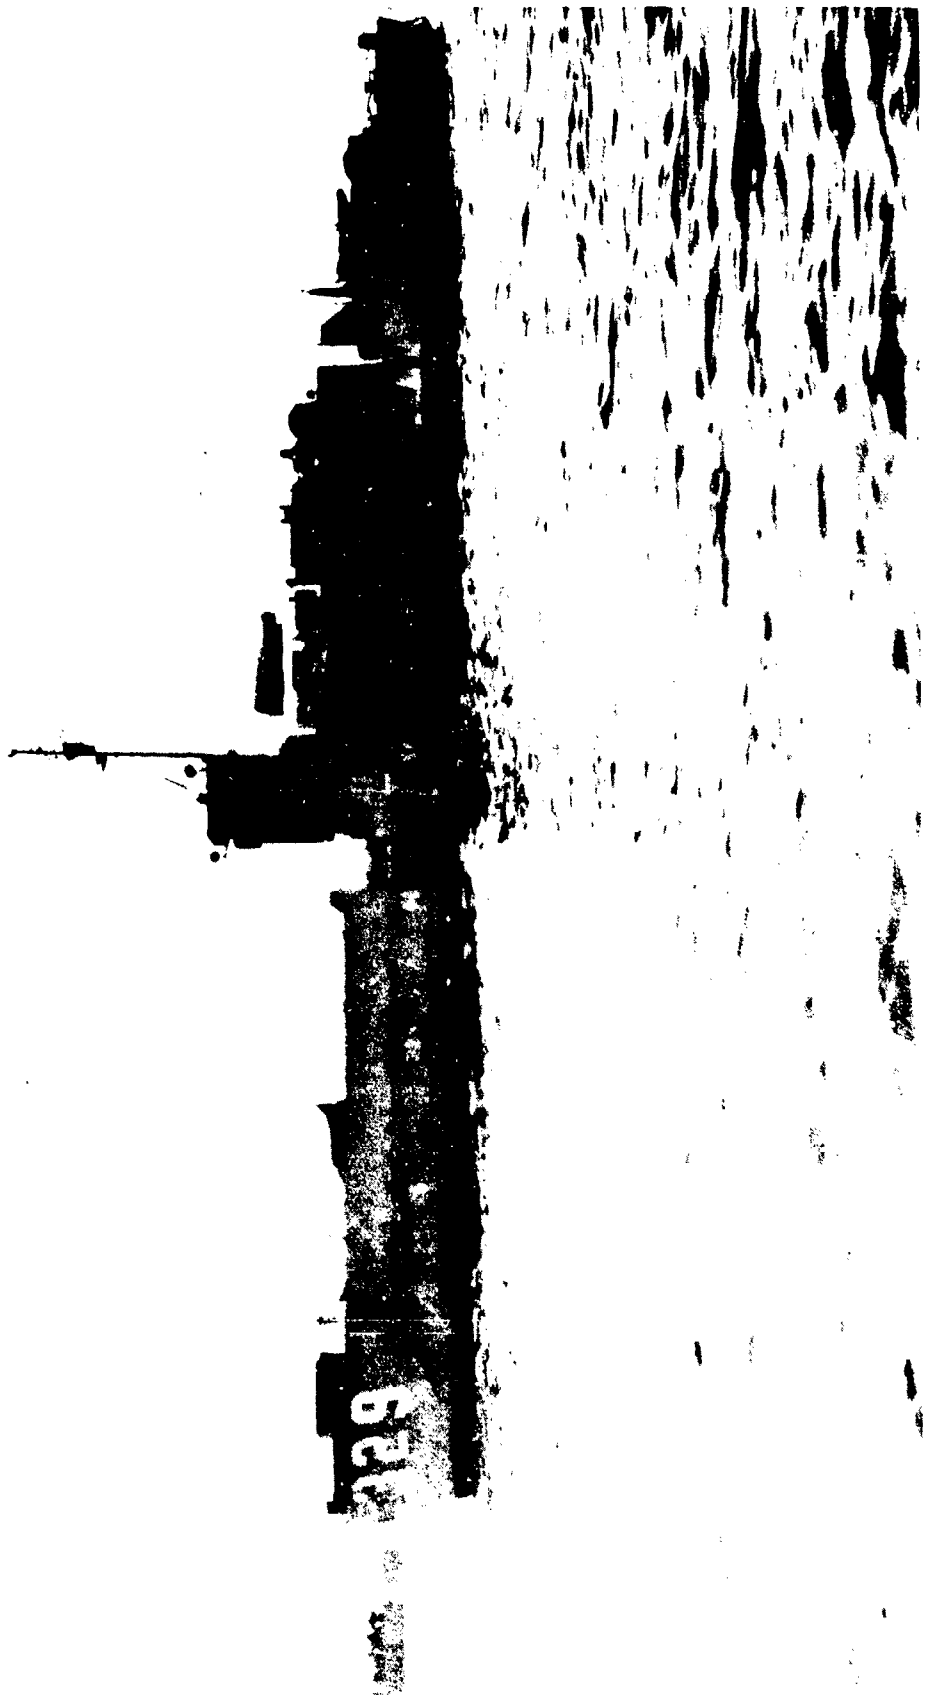
AB-CR-227-290-70. View from port beam after Test B.

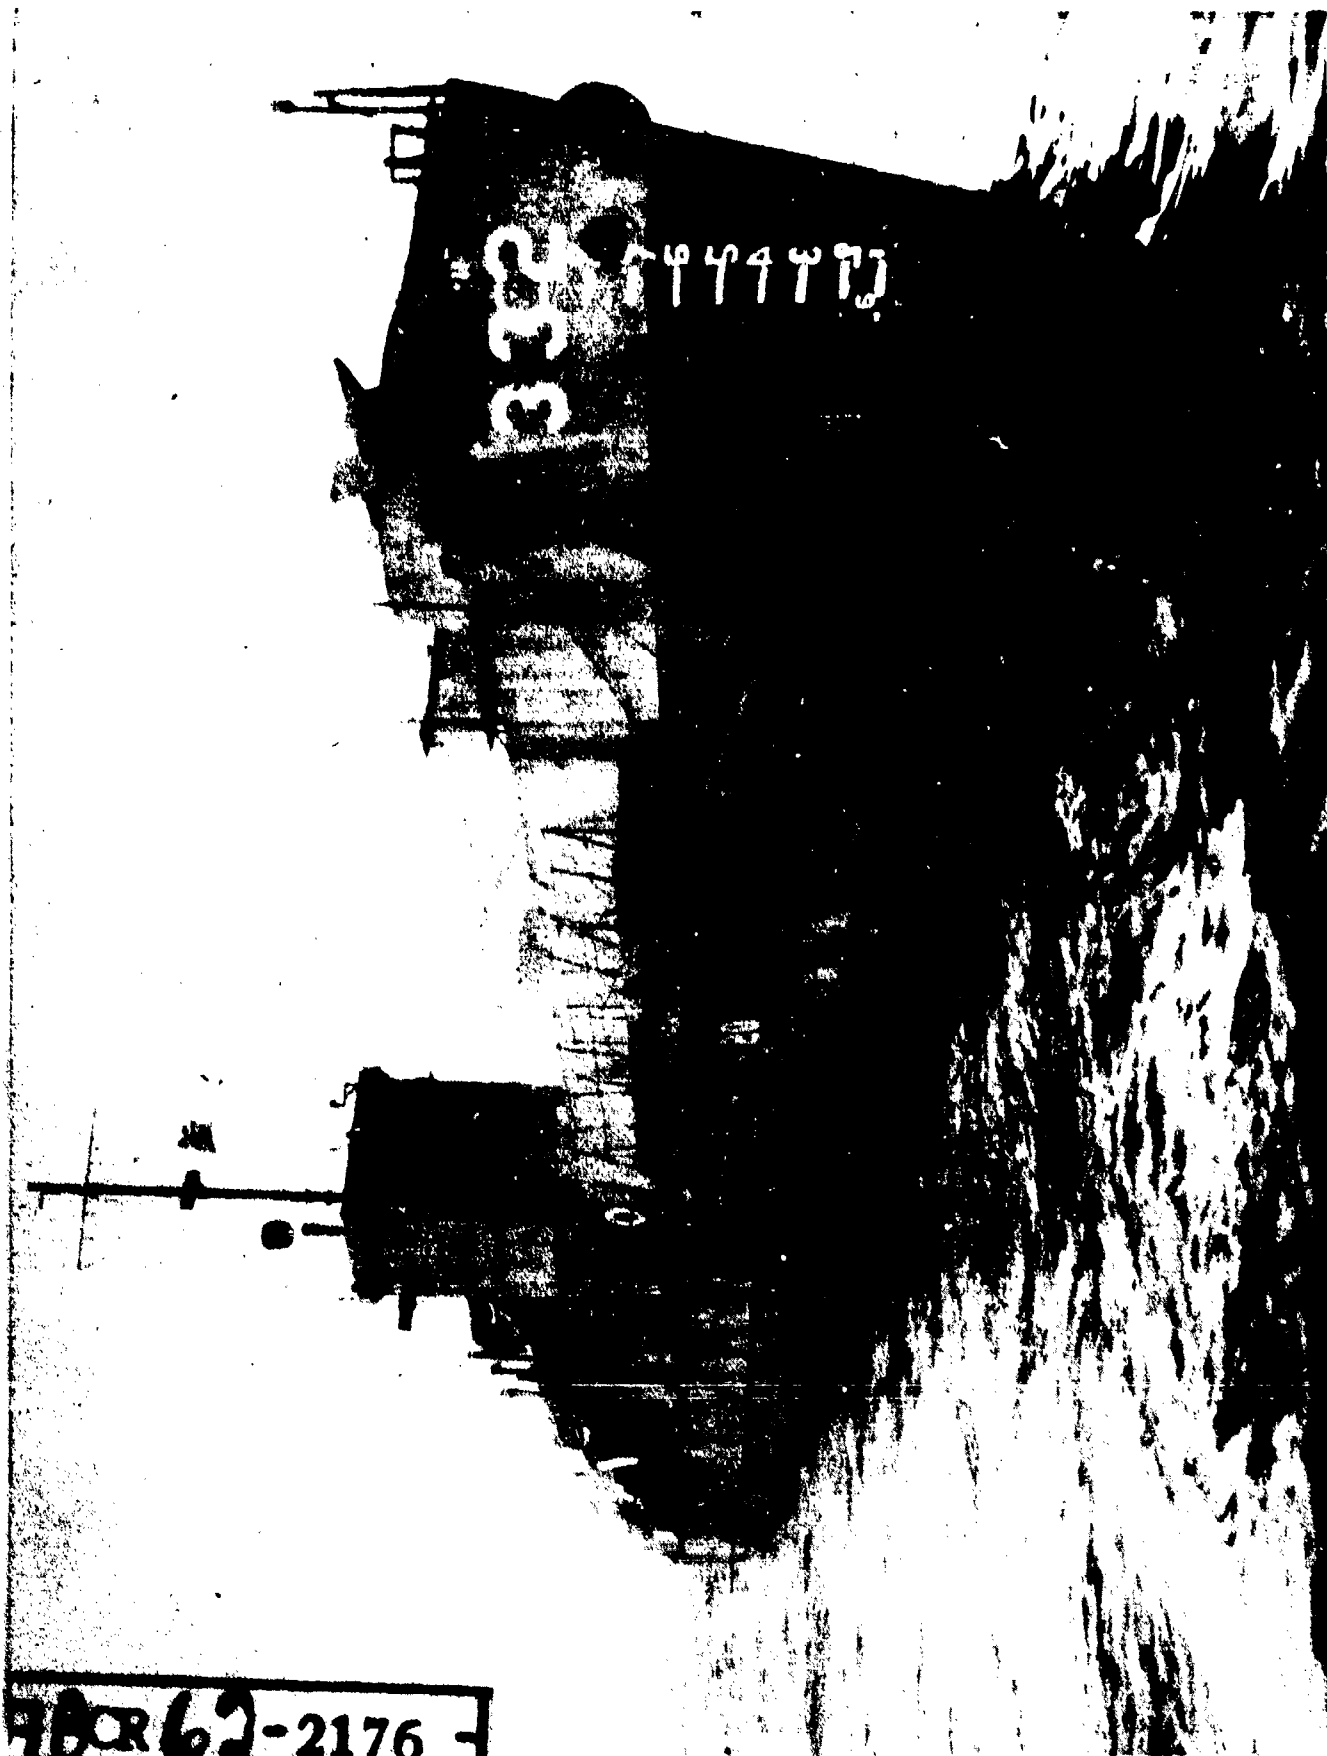
AB-CR-62-2176-1. View from starboard bow after Test B.

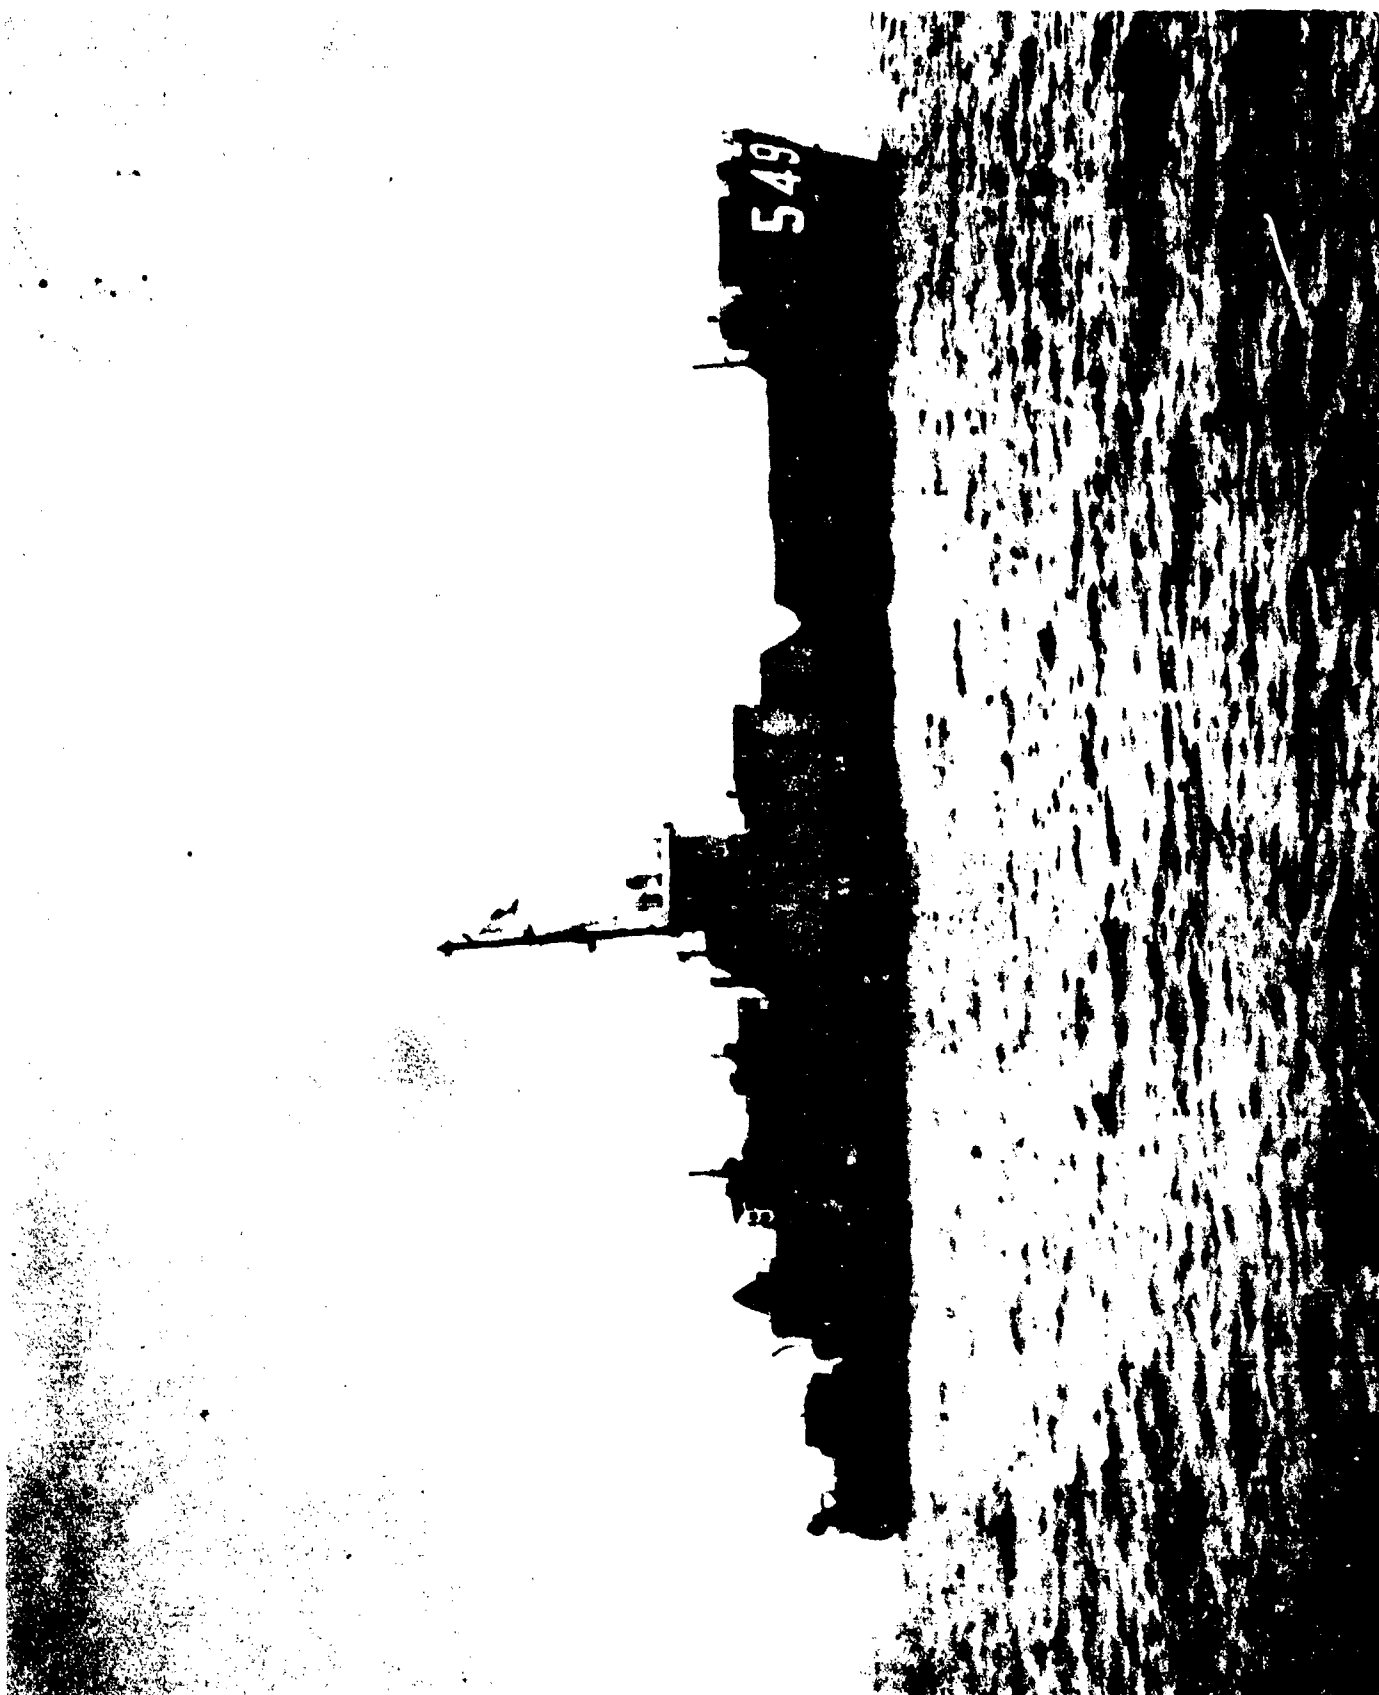
AB-CR-227-290-58. View from starboard beam after Test B.
